# Manhole Inspection Summary

Manhole # S11W\_\_001MH

Insp Date: **12/9/08 10:11 AM**

**Location** Address: **1201 S. Caton**

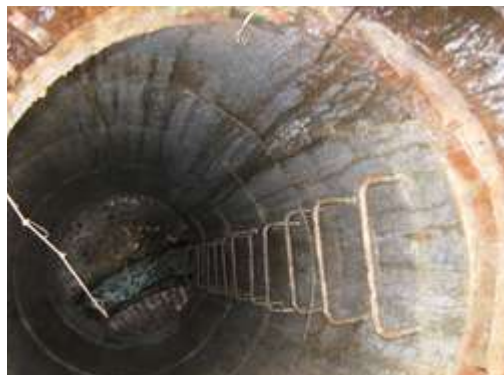
Defect 3

Infiltration: ☐ None ☐ Joint ☐ Cracks ☐ Mortar ☐ Roots ☒ **Wall**

corbel infiltration at wall, barrel infiltration at wall

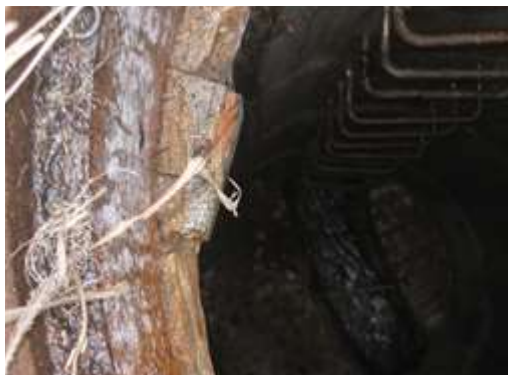
Defect 2

**Frame** Offset: **2** (in.) Condition: ☐ Sound ☐ Cracked ☒ **Leaks**

Condition: ☒ Sound ☐ Cracked ☐ Root Intrusion ☒ **Loose Brick** ☐ Deteriorated

frame offset 2 inches, chimney loose bricks

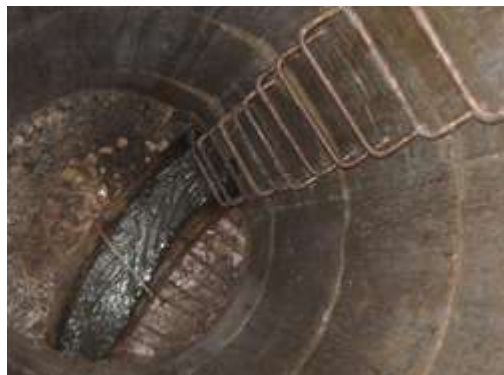
Defect 1

**Steps** Count: **14** Missing: **0** ☒ **Corroded**

steps corroded

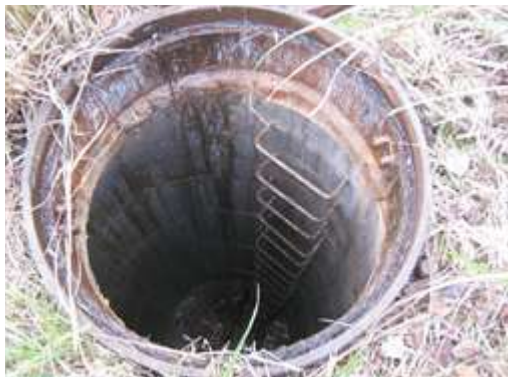
### Defect 4

frame leaks at cover

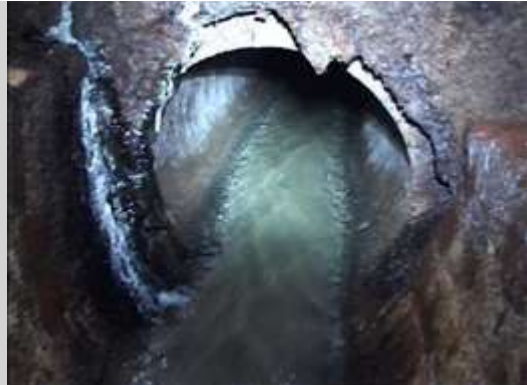
12 O'Clock Outflow

Pipe Height: **15.6** (in.) Rod and Bar (Angled)  
Pipe Material: **Clay** ☐ Pipe Lined  
Invert Depth: **17.17** (ft.) Flow Characteristics: **Fast**  
Deposits: ☒ None ☐ Mud ☐ Sludge ☐ Debris ☐ Grease  
Silt Depth: **0** (in.) Deposits Extent:  
Infiltration: **None** Pipe Seal Cond: **Sound**

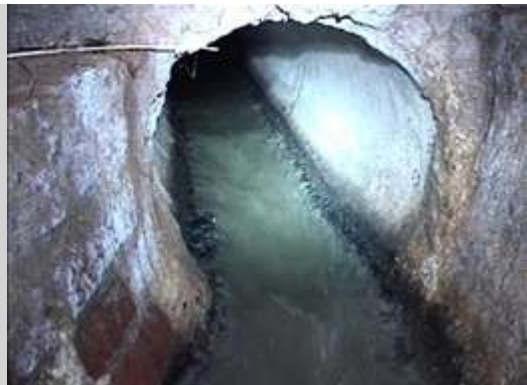
5 O'Clock Inflow

Pipe Height: **15.6** (in.) Rod and Bar (Angled)  
Pipe Material: **Clay** ☐ Pipe Lined  
Invert Depth: **17.25** (ft.) Flow Characteristics: **Fast**  
Deposits: ☒ None ☐ Mud ☐ Sludge ☐ Debris ☐ Grease  
Silt Depth: **0** (in.) Deposits Extent:  
Infiltration: **None** Pipe Seal Cond: **Sound**
